**Environmental
Assessment
and
Biophysical
Review**

**Proposed Development at 2571
and 2971 10th Avenue SW, Salmon Arm,
BC**

Environmental Assessment and Biophysical Review

Prepared For:
WETLAND ALLIANCE: THE ECOLOGICAL RESPONSE

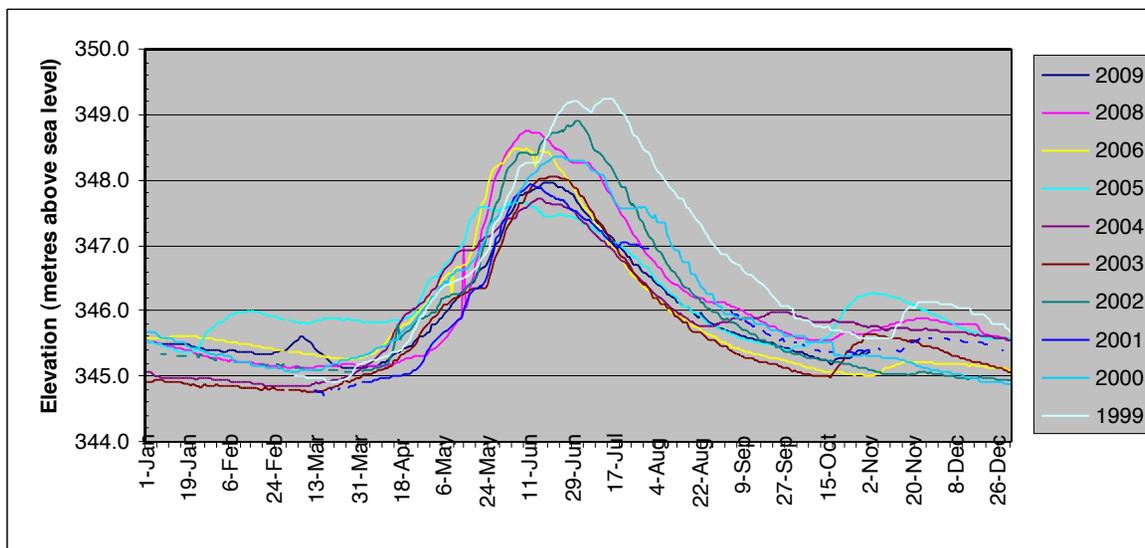
Graph 1. Shuswap Lake water levels recorded from 1999 – 2009

The Property occurs at the confluence of two floodplain systems and its location on the Salmon River Delta makes it highly dynamic, both in terms of the ever-changing hydrologic regime and the associated vegetation community shifts. The Property is very closely linked to the water quality and quantity of the Salmon River and is subject to flooding, erosion, and sedimentation. Simultaneously, the Property occurs partly within (i.e., below) the Shuswap Lake (Graph 1) active floodplain and is directly affected by lake hydrological processes.

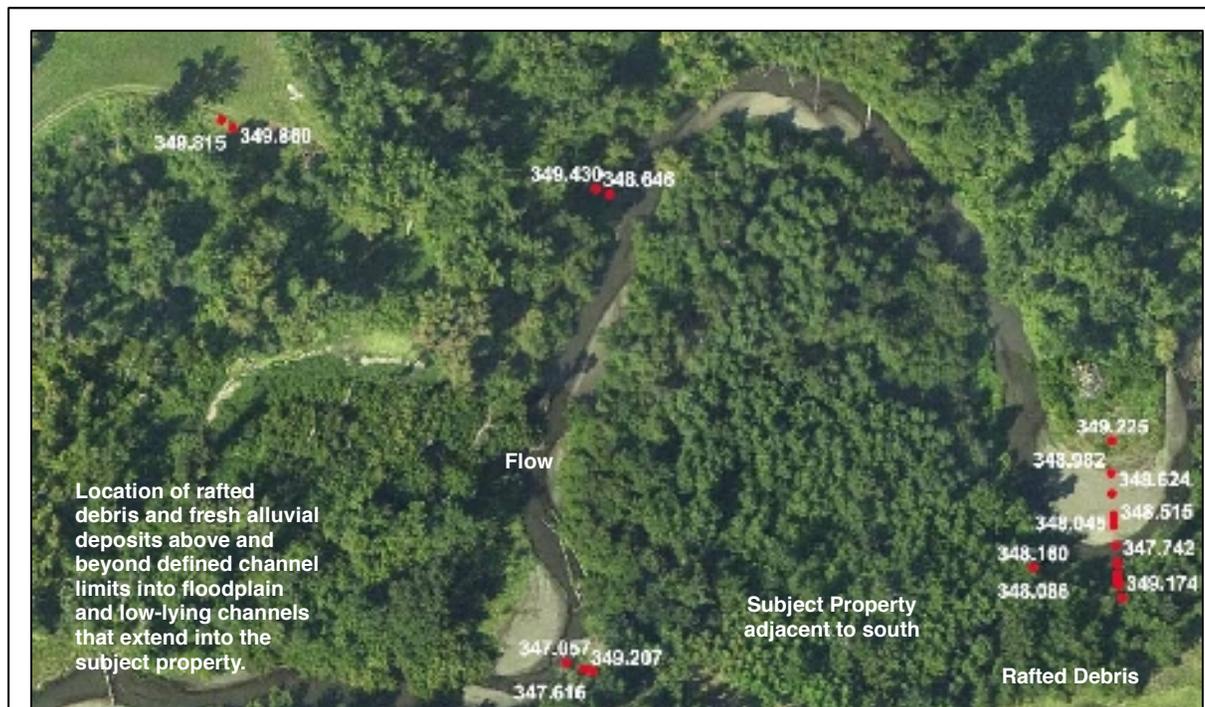
Plate 1 Topographic Survey of Salmon River Channel (Source: Juniper Consulting, 2009)

Topographic surveys along the Salmon River (Juniper Consulting, 2009) indicate that Shuswap Lake backwaters upstream the Salmon River beyond the Property during normal highwater levels (348.7 m.a.s.l.) (Plate 1). The effect of this backwatering creates a 'blocking effect' essentially backing-up the Salmon River causing it to spill over into the adjacent cottonwood floodplain communities (Plate 2) – indicated by alluvial deposits and rafted debris (discussed below). Adding to the resistance of flows through the floodplain is the tortuous meandering of the river channel – having high irregularity. Furthermore, the rail bed situated downstream of the site acts like a dam, further compounding the blocking effect. Evidence of the rail bed influence, having a constricted outlet, can be seen in the accumulation of fine sediments on the upstream side of the railway. Given the above backwatering and blocking factors, the magnitude and timing of the independent spring freshet flood events of the river versus the lake, appear to be causing a more elevated active floodplain than that estimated for the downstream side of the railway, which is based solely on the Shuswap Lake normal highwater level.
