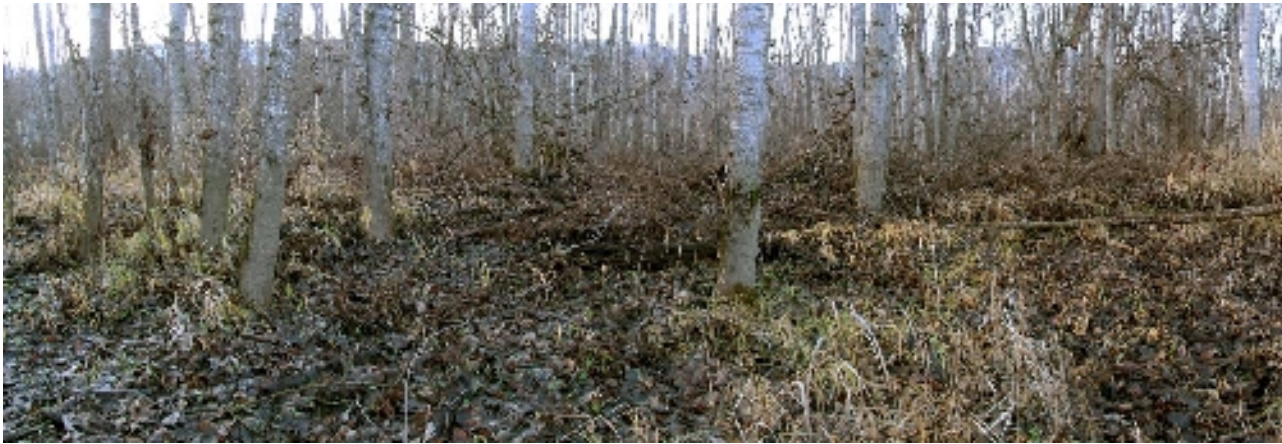
Photo 7. Photo taken in fall 2008 (contributed) showing the lichen/silt line (shown as graying discoloration in photo) on cottonwoods within the mid-bench floodplain communities that occur through the Property. These features/deposits indicate the highwater level through the active floodplain.

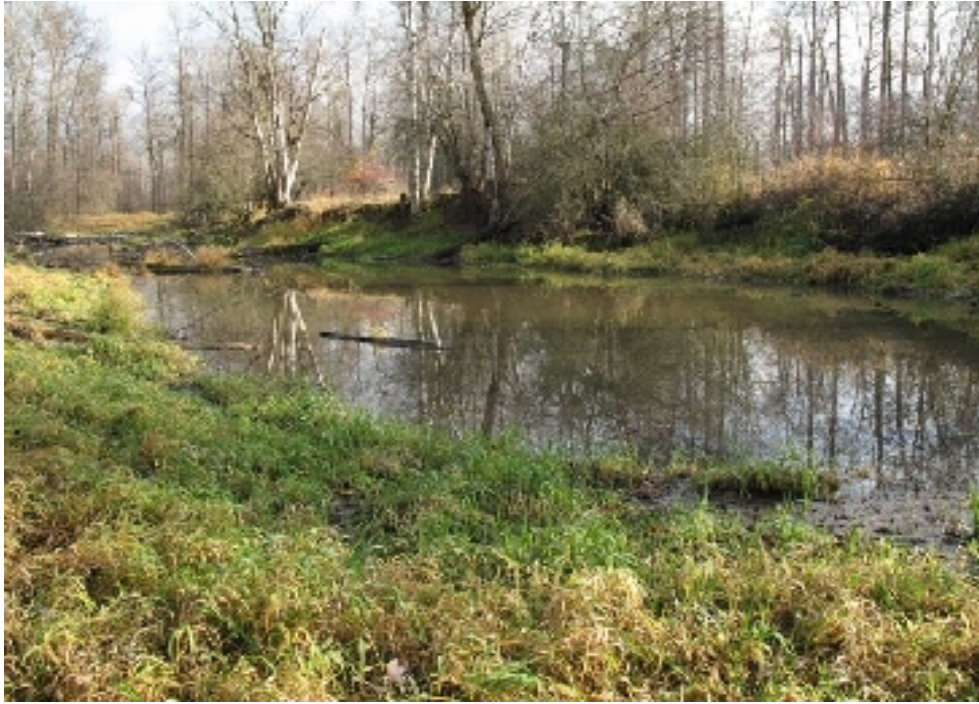
Photo 9. Photo taken in fall 2008 (H. Tyson) showing the ox-bow water wetland. In 2009, during channel surveys, looking into the property from the river toward the ox bow water, there is evidence of a surface water connection to this feature indicated by rafted debris and fresh alluvial deposits (sand) just beyond the top of bank over the natural levee.

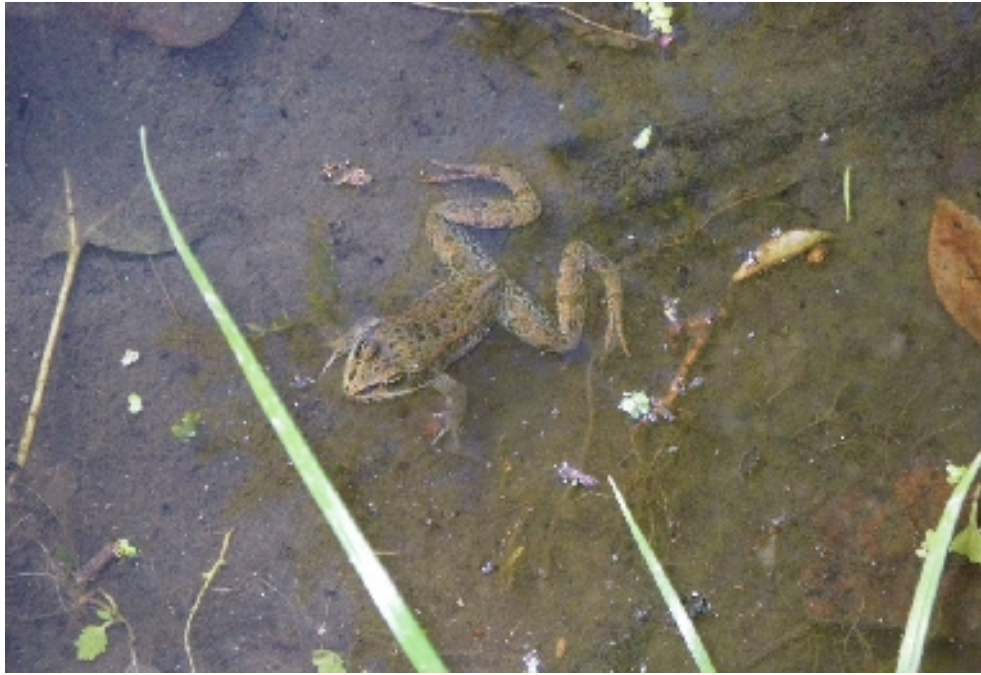
Photo 11. Columbian spotted frogs (above) and Pacific chorus frogs were both documented in small off channel waters adjacent to the mainstem flows of the Salmon River. The shallow open water wetland and flood channels likely provide critical reproductive habitat for amphibians.
